REPORT OF MARINE SURVEY
pre-sale and estimated market value
(for insurances use)
of the vessel "Name"

Purpose: Pre-sale survey of the sail catamaran "Name"

| Vessel's type | Sloop sail catamaran |

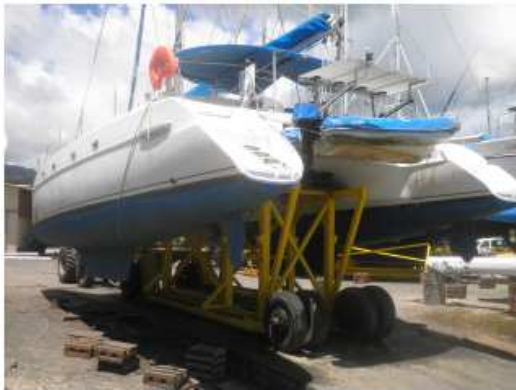
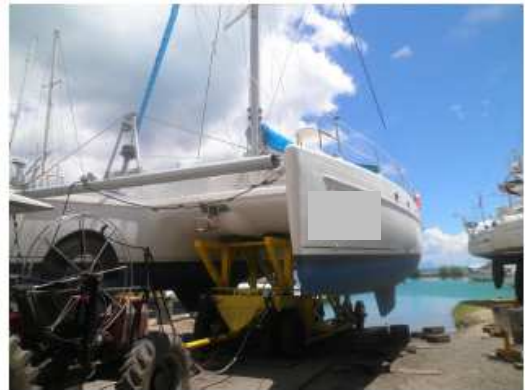
The hull is in very good condition ; no mark of hit nor of delaminating, not any osmosis bleb.

A slight mark from the building moulds can be seen on the mediane line of the hull.

This is due to building and demoulding.

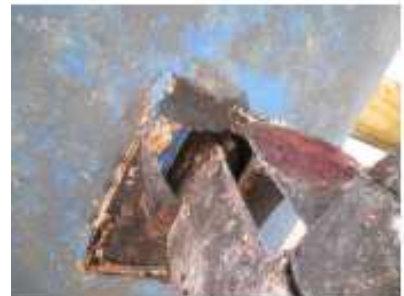
The propeller is of aluminium; no mark of hit nor of deformation. Good balance. The antifouling onto the propeller does not exist any longer, but there's still a PRIMOCON primer. No free move observed in the axis.

The saildrive anode was settled in August 2011; it's 20% worn, it has fulfilled its shield function. It's not to be replaced in a near future.

The saildrive external bib (enhances water trickles flow, to avoid perturbations) is damaged; this doesn't impede the good work of the saildrive. **C15**

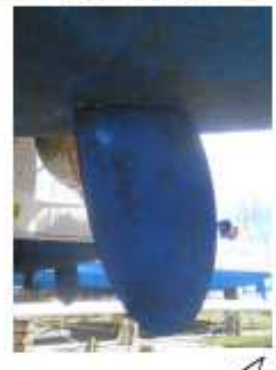
The rudder is in very good condition. A slight free move can be observed on the rudder rings: this is inconsequential usual wear.

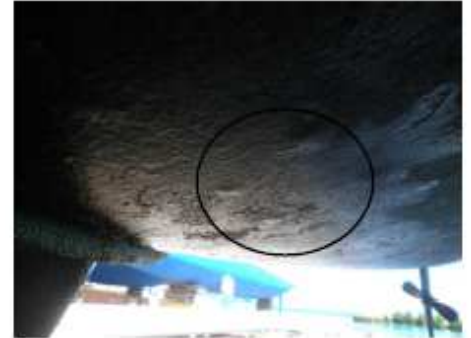
3 six-millimeters blebs can be seen, aft of the keel embryo, onto the inner part of the hull.

This osmosis is very local and presents no hazard for the hull integrity. **C16**

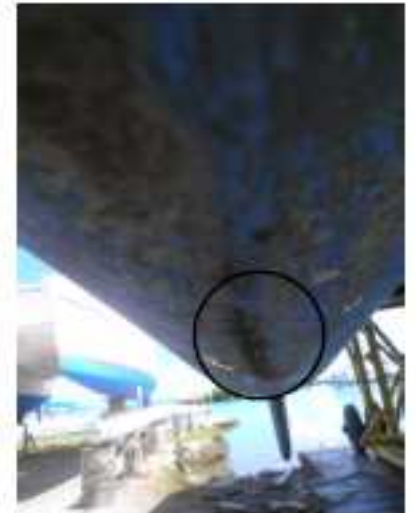
A mould line mark along the mediane is slightly more noticeable, 1,4 m from the bow, on 20 cm, and aft of the keel embryo.

Small defects can be seen along this mediane, the gelcoat is still on.

They're not hazardous for the hull structure.

This is due to the building and the demoulding.

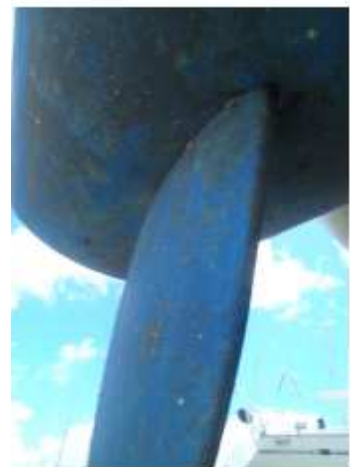
The rudder is in good condition.
A slight free move can be observed on the rudder rings: this is inconsequential usual wear.

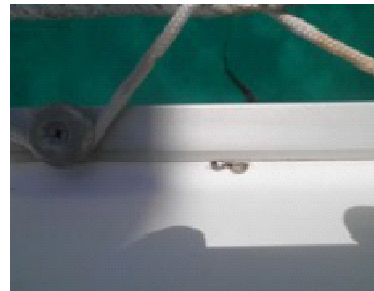
A few hits and grazings can be seen on the transoms.

Part of the fore deck got supple on port, just at the beginning of the roof, without severity.

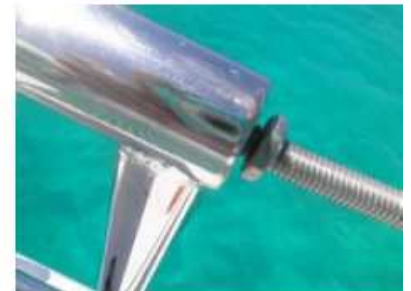
Starboard upper life cable's nut is loose. **A1**

Port life cables are loose. **B1**
