REPORT OF MARINE SURVEY
pre-sale and estimated market value
(for insurances use)
of the vessel "Name"

Purpose: Pre-sale survey of the sail catamaran "Name"

| Vessel's type | Sloop sail catamaran |

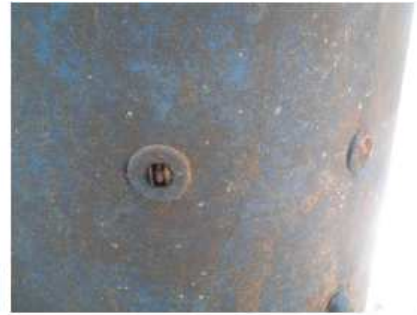
The loch through-hull is in good condition, the paddlewheel has been cleaned and its rotation is free.

All the through-hulls ave been inspected and are in good condition.

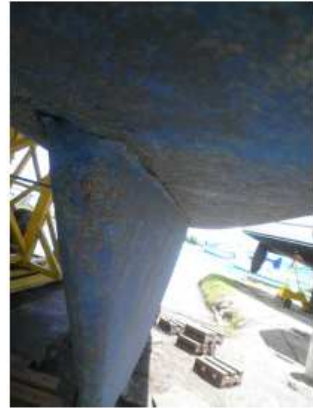
SAIL DRIVE

The keel embryo which stands as an anti-drift flat surface is in good condition. Its bonding to the hull shows no defect and is tight.

Good condition.

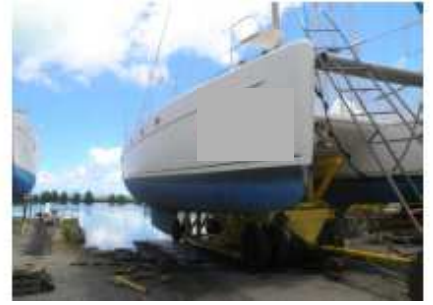
The hull is in very good condition; no mark of hit nor of delaminating.

3 six-millimeters blebs can be seen, aft of the keel embryo, onto the inner part of the hull.

This osmosis is very local and presents no hazard for the hull integrity. **C16**

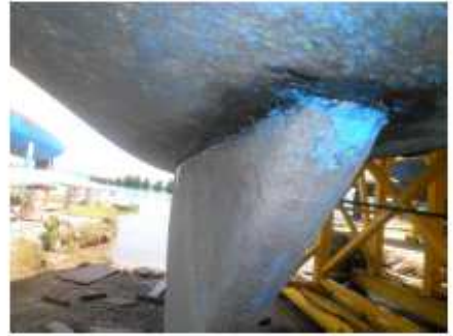
The keel embryo which stands as an anti-drift flat surface is in good condition. Its bonding to the hull shows no defect and is tight.

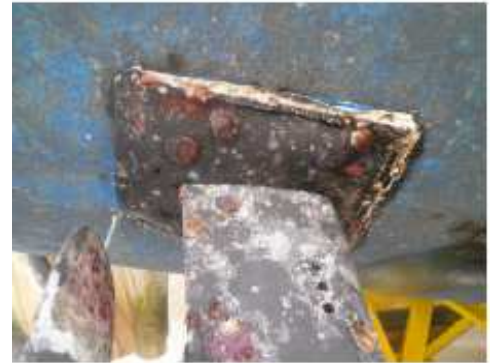
SAIL DRIVE

Good condition.
Raw water aspiration holes are free from any obstruction.
No mark of hit.

The propeller is of aluminium -no mark of hit nor of deformation.
Good balance.
The antifouling onto the propeller does not exist any longer, but there's still a PRIMOCON primer.
No free move observed in the axis.

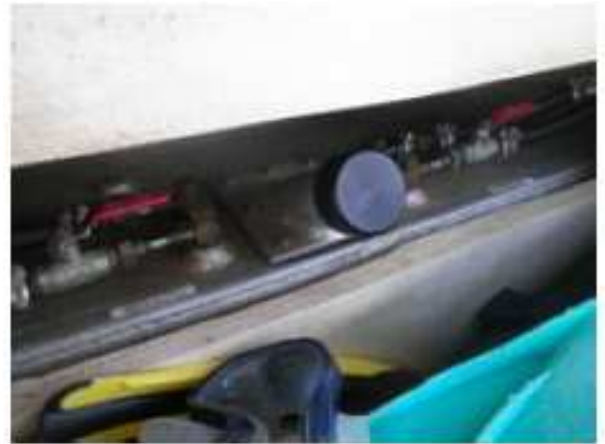
CARIBE dinghy in medium condition.

Outboard engine is in medium condition.
